The **information** you need to **enhance performance** and **profitability**

Take the fastest and most cost-effective route to the failure data you need. Universal Instruments Failure Analysis services. We have already invested in specialized, precision analysis tools, and the knowledge of Topic Experts whose collective expertise covers every packaging and assembly technology in depth.

Component level failure analysis

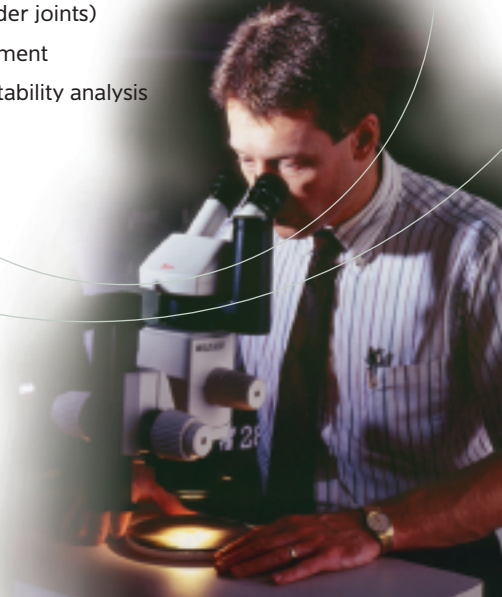
BGA packages featuring nickel/gold plated interconnects frequently show high failure rates at end of line and in the field, over time. Detailed analysis of sample packages allowed us to characterize the weaknesses inherent in this metallurgy, and recommend changes to enhance product lifetime and end of line yield:

- Applied analysis:
 - Dye penetration, cross section, shear test
 - Solder rupture and inter-facial failure modes identified
 - Prediction of "time zero" and long term field failures
- Our response:
 - Recommend alternative finish materials
 - Qualification of substrates using "ball shear" and "torque" testing
 - Compile data to inform assemblers of the performance limitations of nickel/gold
